MTL TR 90-30

# METALLURGICAL ANALYSIS OF LEAKING TRAY PACKS

U.S. ARMY MATERIALS TECHNOLOGY LABORATORY  
METALS RESEARCH BRANCH

May 1990

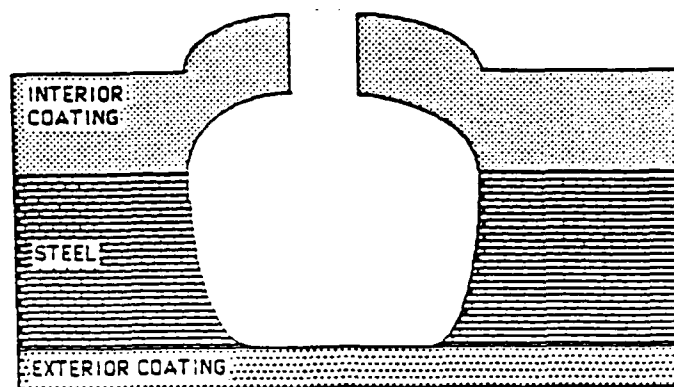
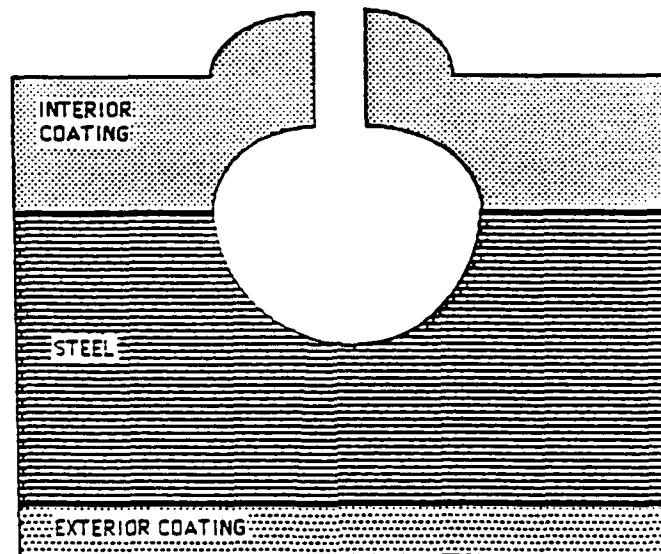
A review of our findings clearly shows that leakers are a consequence of corrosion which initiates in the interior of the tray pack at the coating/steel interface and proceeds outward to the exterior surface where either a gray spot or pin hole is observed. All of the food stuffs contain water and salt, an aggressive environment. Chloride ions and  $H_2O$  penetrate into the vinyl coatings followed by localized mass transport of ions through coating defects. This process is continued into and through the epoxy coating at pores or cracks with follow-on substrate (steel) ionic/electronic charge transfer reactions (corrosion) occurring at the coating/metal interface. Corrosion beneath an organic coating is a special example of an occluded corrosion cell where a pocket of liquid is isolated from the bulk liquid (as in pitting, crevice corrosion, or stress corrosion cracking) and chemical changes occur in the liquid resulting in intensification of localized corrosion. Until corrosion (pitting) proceeds through the entire steel thickness, there is no evidence of a gray spot at the exterior clear epoxy/metal interface. This difference is shown schematically in Figures 11a and 11b.

Figure 11. Schematic models showing the formation of blister/pit on the interior with 'gray spots' or no 'gray spots' on the exterior of the tray.

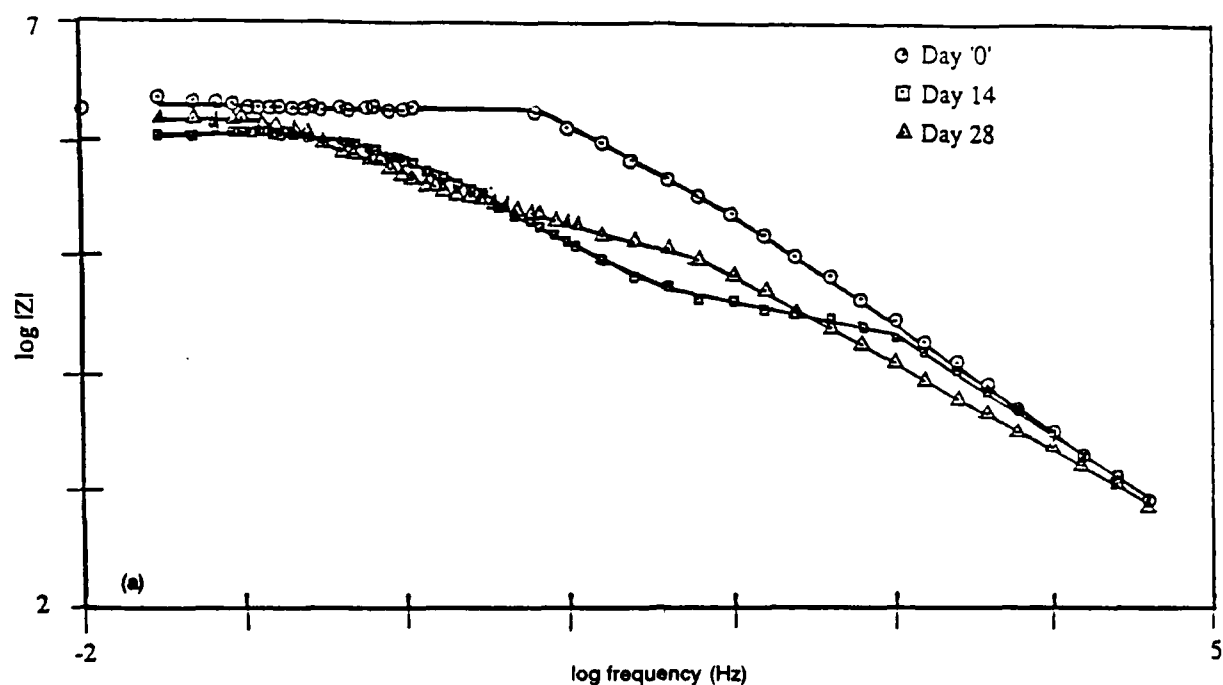
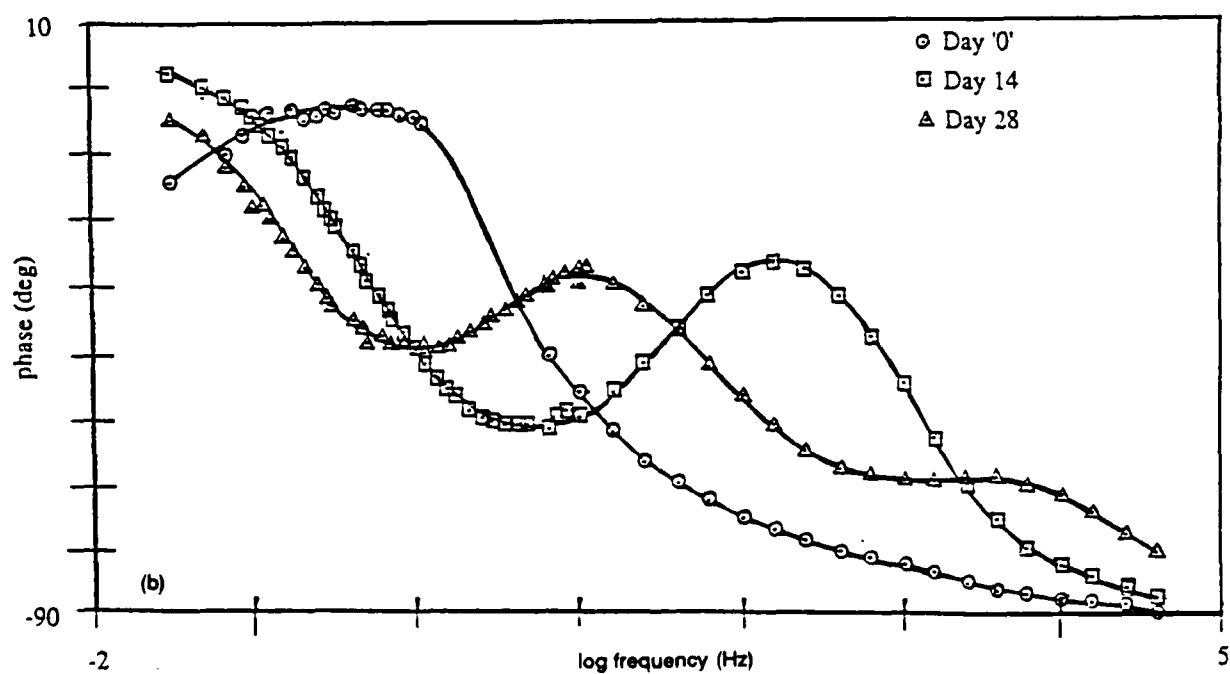
Figure 12 contains Bode plots, (a)  $\log |Z|$  versus  $\log$  frequency and (b)  $\theta$  phase angle (deg) versus  $\log$  frequency, which compare the behavior of the new HGW coating exposed to 3.5% NaCl solution for 14 and 28 days. The polarization resistance, determined by extrapolation from the linear region at low frequencies to the  $\log |Z|$  axis intercept, (see Figure 12a) remains relatively unchanged from 0 to after 14 and 28 days of exposure. However, the phase angle plot (see Figure 12b) shows significant differences in behavior as a function of exposure time. The new peak after 14 days indicates another phenomena is occurring, differing from the initial one of penetration of the solution into the coating. This probably represents corrosion at the metal/coating interface.

Figure 12. Bode plots for (a) magnitude and (b) phase angle for HGW coating tested in 3.5% NaCl for 0, 14 and 28 days exposure.

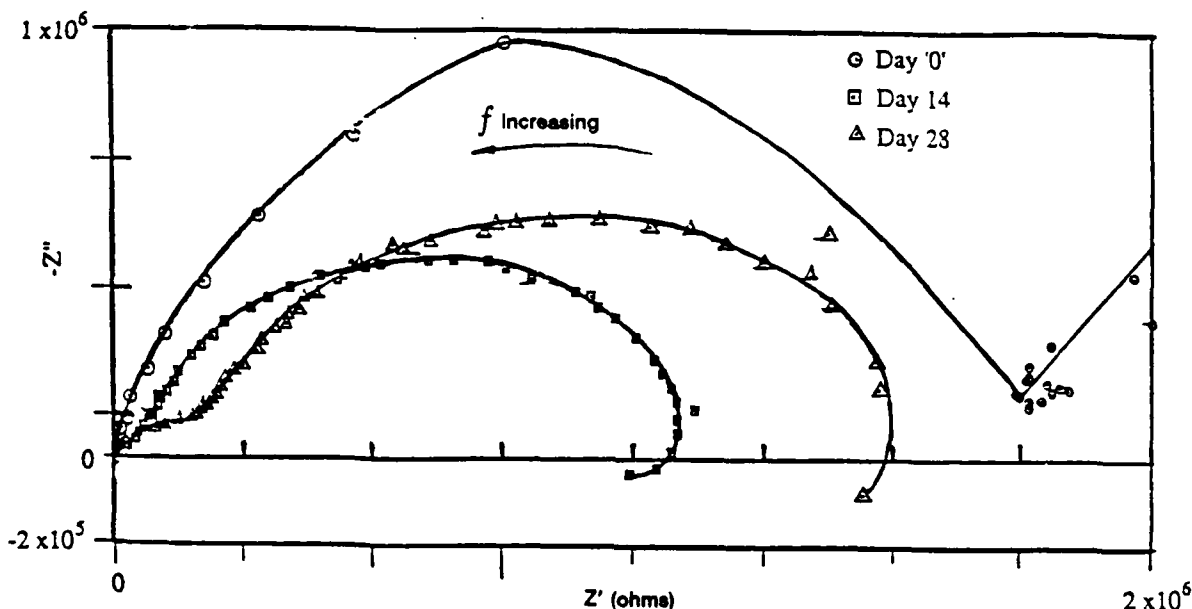
Figure 13 contains Nyquist plots for the same coating exposed for 0, 14, and 28 days to 3.5% NaCl solution. The response curve after one day of exposure is a relatively large semi-circle. The impedance behavior after 14 and 28 days shows that the high frequency intercept of the curves with the  $Z'$ -axis is the same, but the response curves become smaller semi-circles (decreasing in area with increased exposure time) with the center of the semi-circle lying along the  $Z'$ -axis. An estimate of the polarization resistance may be made from the intersection of the low frequency end of the semi-circle with the  $Z'$ -axis. Thus, the polarization resistance decreases with increasing exposure time.

Figure 13. Nyquist plot for the same HGW coating, as shown in Figure 12.

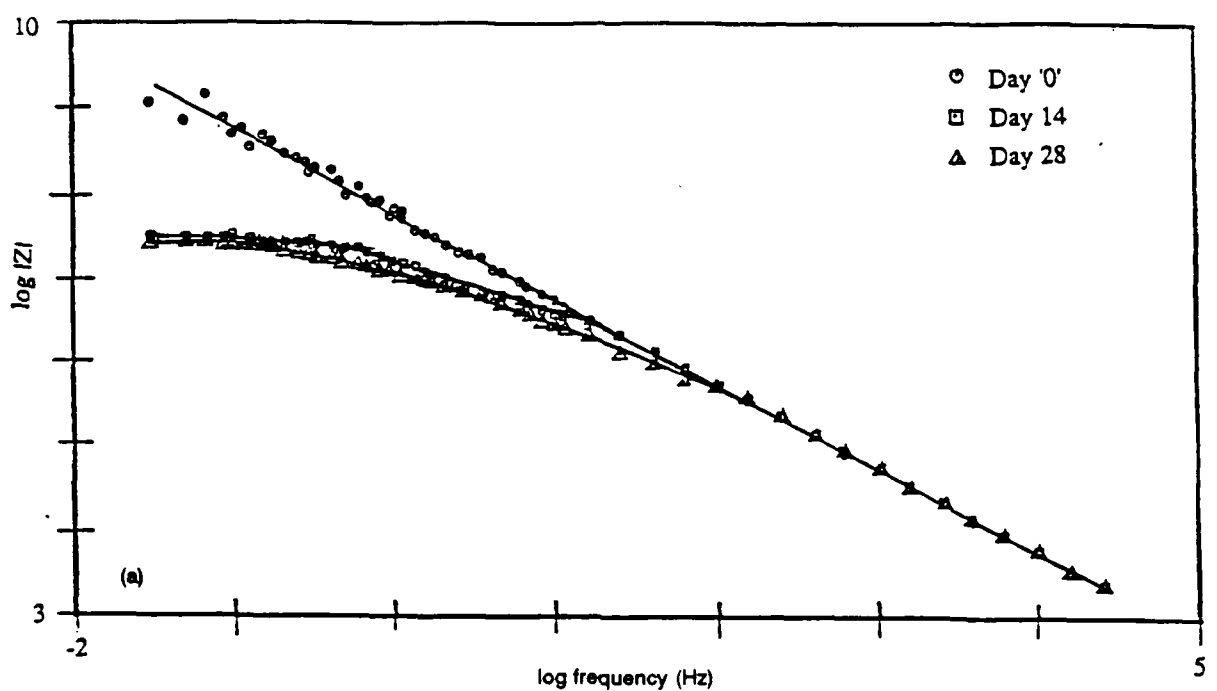
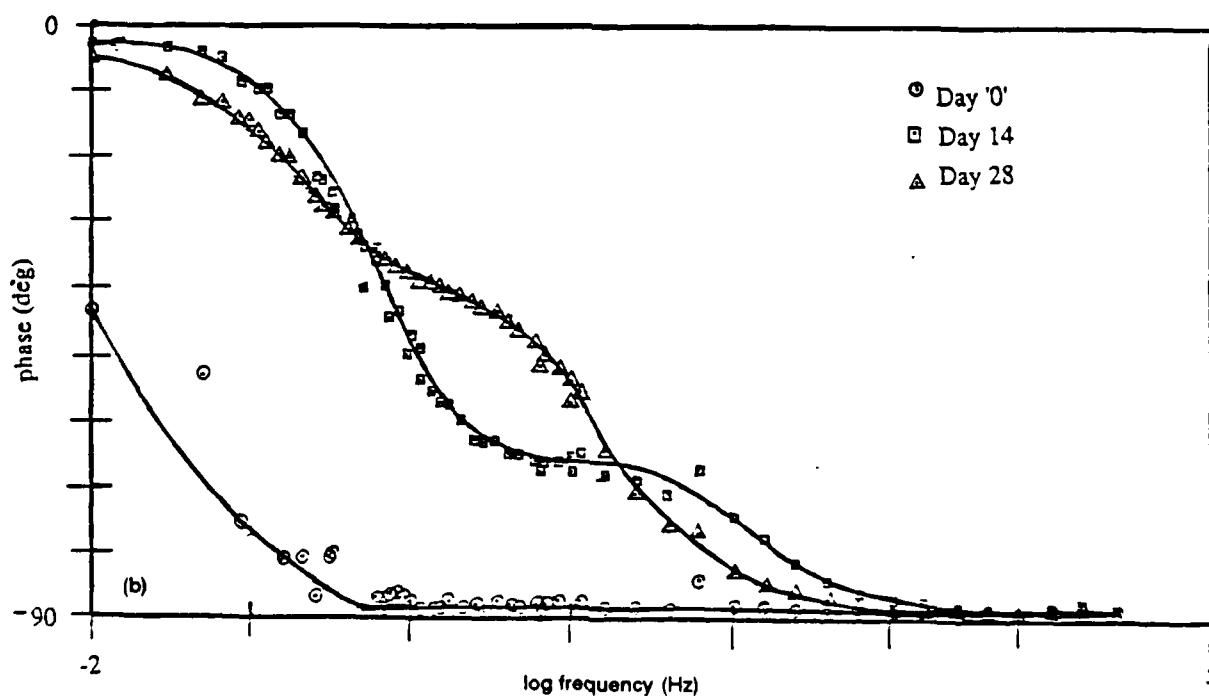
Similar AC impedance measurements in 3.5% NaCl solution were made on the current coating system. Bode and Nyquist plots for this system are contained in Figures 14a, 14b, and 15, respectively; generally, the impedance behavior of the multilayer system is qualitatively similar to that of the new high gloss (HGW) coating. Nevertheless, there are some discrete differences which are discernable from the plot of polarization resistance as a function of exposure time, as shown in Figure 16. The presently used coating system has a much higher initial polarization resistance ( $R_p$ ) than the HGW coating ( $1 \times 10^{10}$  ohms  $\text{cm}^2$  versus  $6.3 \times 10^9$  ohms  $\text{cm}^2$ ), but as the coating system is exposed to 3.5% NaCl solution,  $R_p$  decreases with exposure time and levels off to  $6.3 \times 10^7$  ohms  $\text{cm}^2$ . Although some coating degradation has occurred,  $R_p$  after 28 days of exposure remains significantly above the critical value<sup>1</sup> of  $10^6$  ohms  $\text{cm}^2$ , below which corrosion of the tin-free steel occurs. The  $R_p$  of the HGW coating is consistently much lower and even approaches the critical value of  $10^6$  ohms  $\text{cm}^2$  after exposure time of 28 days.

Figure 14. Bode plots for (a) magnitude and (b) phase angle for the current coating system tested in 3.5 % NaCl for 0, 14 and 28 day exposures.

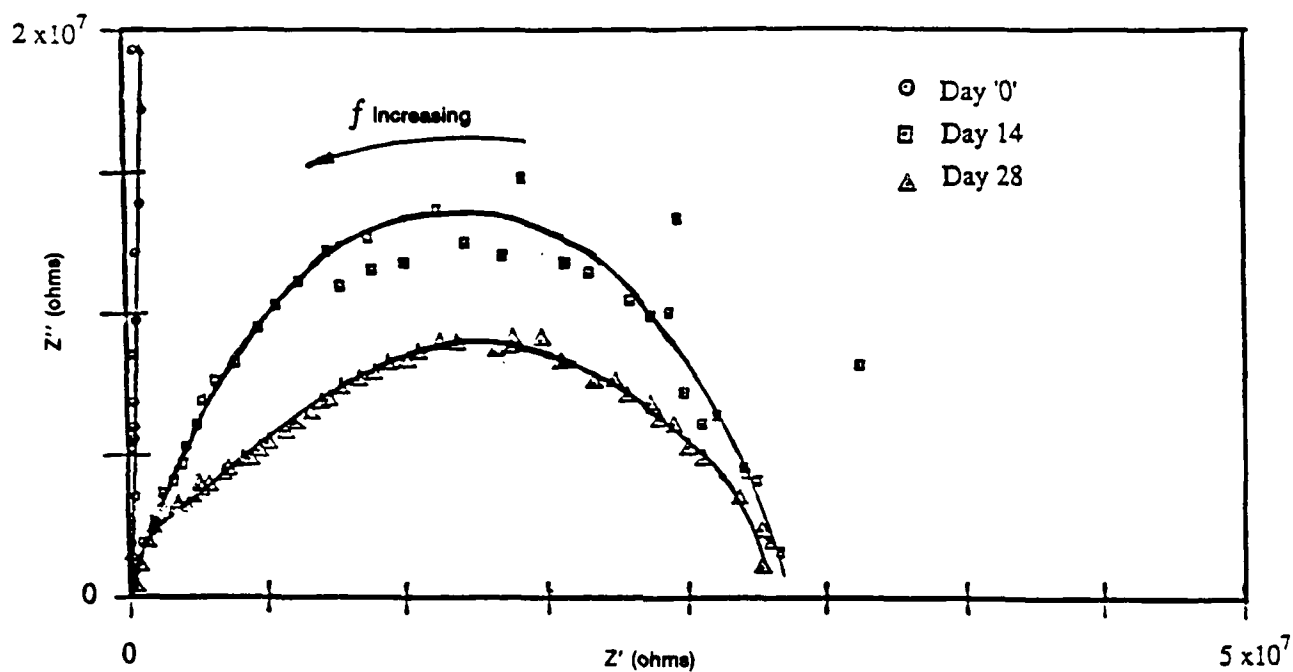
Figure 15. Nyquist plot for the current coating system data as shown in Figure 14.

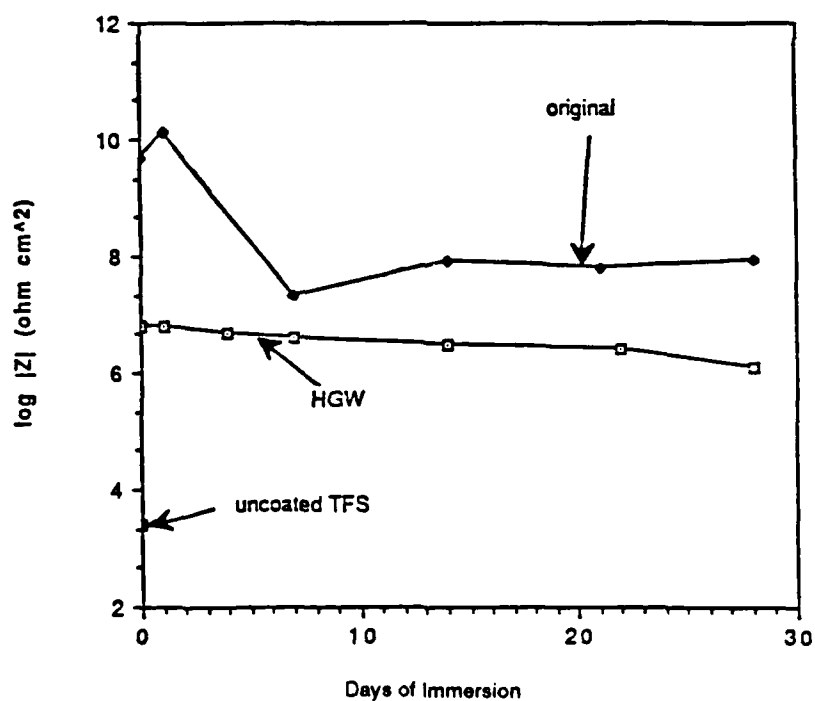
Figure 16. Comparison of the polarization resistance of the HGW and the current coating system as a function of days of exposure to 3.5% NaCl.
